ERIE COUNTY COMPTROLLER

October 28, 2019

In the past month, Lake Shore Road was the site of some road repairs. Near the section crossing Little Sister Creek, there appears to be a significant drop off from the pavement to the shoulder. Our audit team measured the vertical pavement-edge drop off (PEDO) to be 7 inches. In addition, the angle of the drop-off appears to be just over 60°. We took measurements at multiple spots near the intersection of Wendt and Lakeshore Roads. The large, steep drop-offs were observed at many spots along the repaved project, although measurements at other spots were not taken.

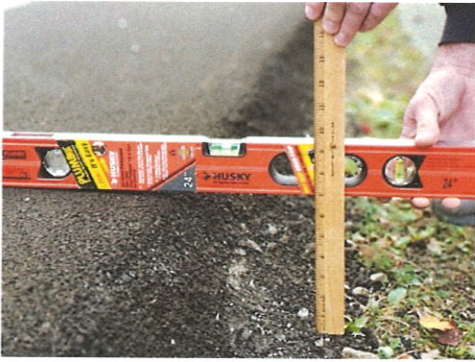
Lake Shore Road – 7 inch Drop-off

A 2006 AAA Foundation for Traffic Safety study recommends that highway agencies require routine comprehensive sampling of PEDO on their roads, suggesting that any drop-offs of 5.1 centimeters (2 inches) or more should be corrected.

The *Manual on Uniform Traffic Control Devices* provides recommendations for signs used to warn motorists of unexpected conditions. For example, if the pavement-edge drop-off is less than 7.6 centimeters (3 inches), a "Low Shoulder" sign should be used. If the PEDO exceeds 7.6 centimeters (3 inches), a "Shoulder Drop Off" sign is recommended.

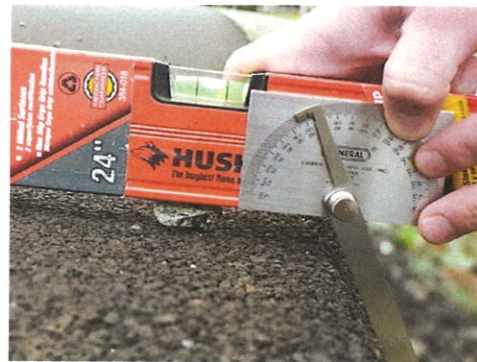
Lake Shore Road - 62° angle Drop-off

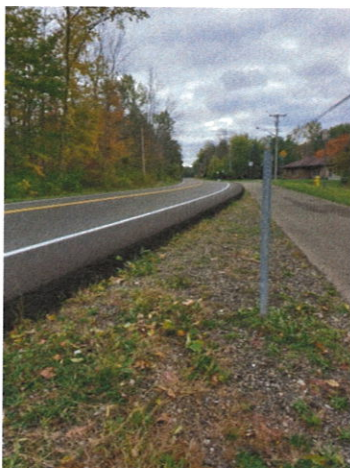
I have attached photos of the measurement of the drop-off, and a photo of the larger section of road where the measurements were taken. Please note the metal post in the one photo, which may be a dangerous fixed object that may require attention as well.

Lake Shore Road – Near Intersection with Wendt Road
