Buffalo Niagara Convention Center

TASK 6 REPORT APPENDIX

Structural Site Assessments

Buffalo Niagara Convention Center Phase II & Phase V Buffalo, New York

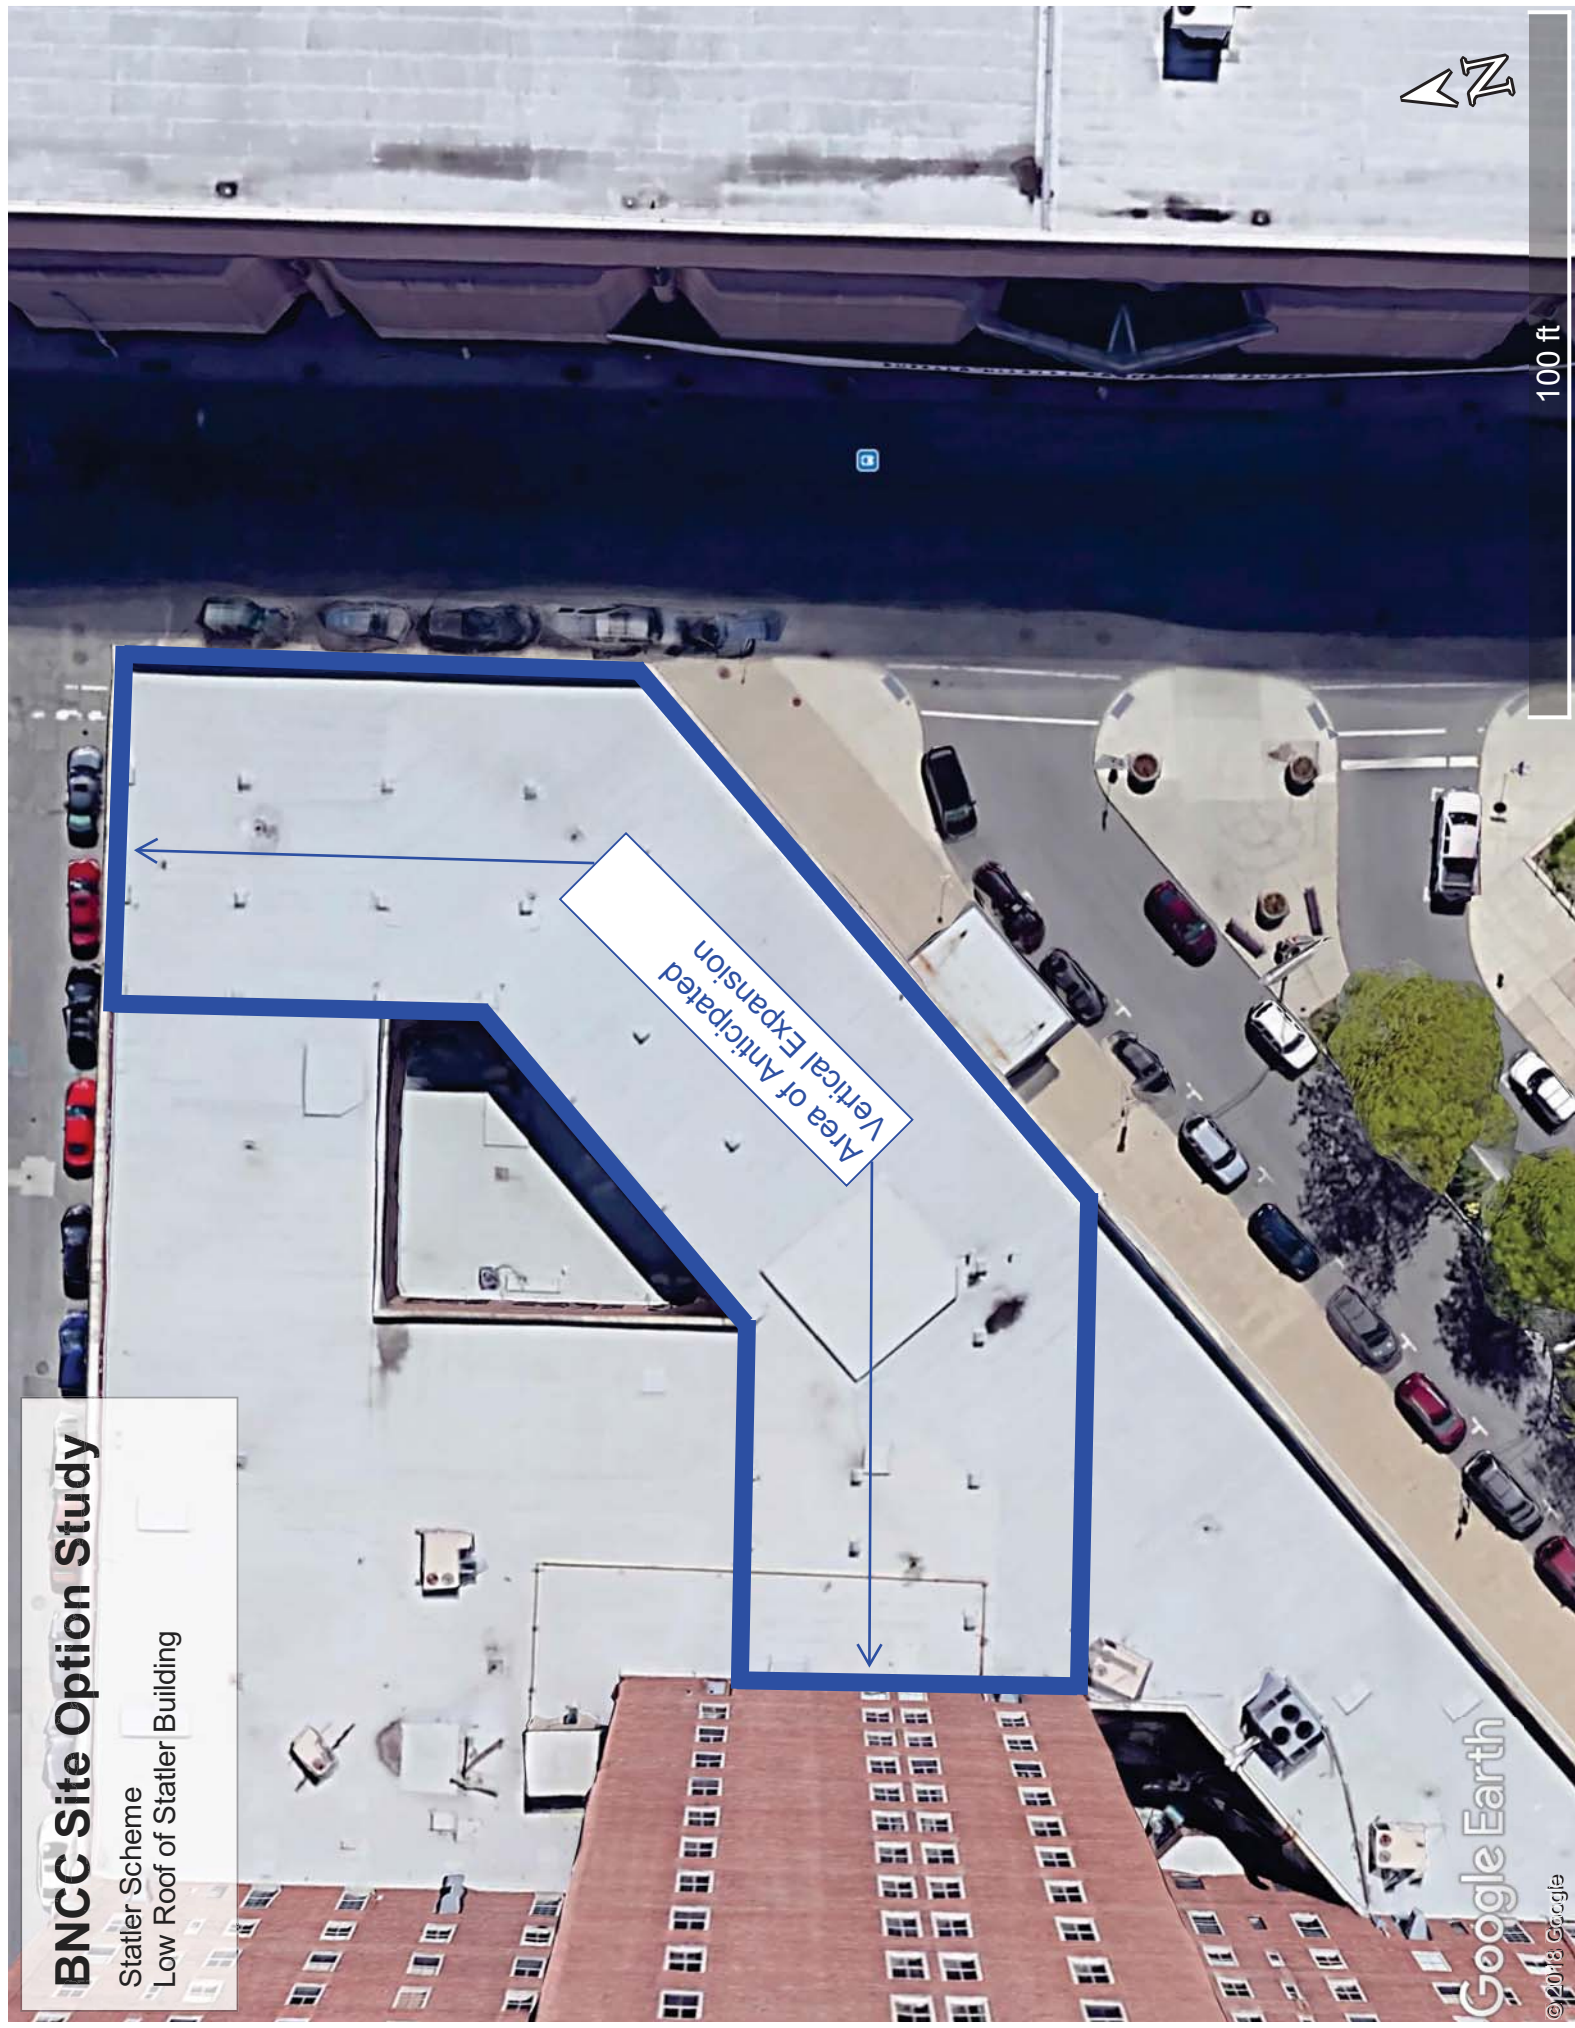
Area of Anticipated
Vertical Expansion

The question then becomes can the existing columns and foundations support the added exhibit floor and roof along with seismic and wind forces?

Finally, the existing foundations for the Statler Building are unknown at this time. It may be possible and very expensive to reinforcing some of the columns designed for future expansion to eliminate the 20'x20' grid on the hall floor. The issue with doing so however, is there would be no way to analyze their capacity to determine if they could support the applied loads.

It is unlikely that the columns and foundations would work for these additional loads. Therefore, it is anticipated that additional columns and foundations would need to be added below the existing floor. The new columns would then extend up thru the current floor to the new exhibit hall floor and roof.
